TSUE9080QIS-ARMS

E82 1 Series/E89 Z4/E9X 3 Series (NOT XI) FRONT UPPER CONTROL ARM BEARING KIT WITH CONTROL ARMS (Assembly)

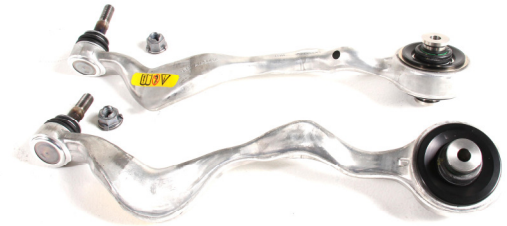
Parts list for kit:

- 2 Bearings assembled in aluminum housings
- 4 Stainless steel bearing inserts
- 2 External spiral-loc rings (pre-installed)
- 2 M12 Bolts

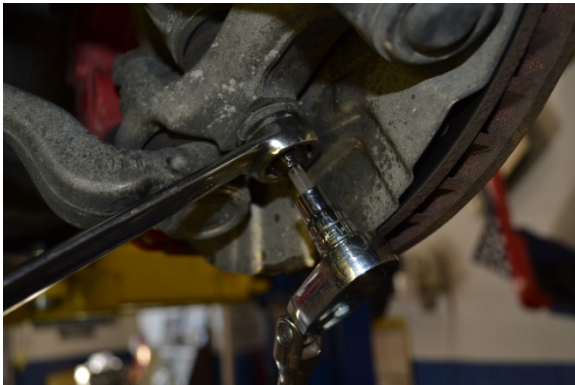
- 6) Remove outer ball joint nut
 - a) Use a 21mm box-end wrench to loosen the nut
 - b) Insert T-40 torx into ball joint pin to hold ball joint from spinning while loosening the nut

- i) NOTE: Only use the torx to keep the bolt from turning - do not turn the torx bolt
 - ii) NOTE: Depending on the manufacture of the upper control arm the torx maybe a different size and possibly a hex. Please check and use the appropriate tool.

- c) A ball joint puller should not be necessary as this is the newer style non-press fit type joint

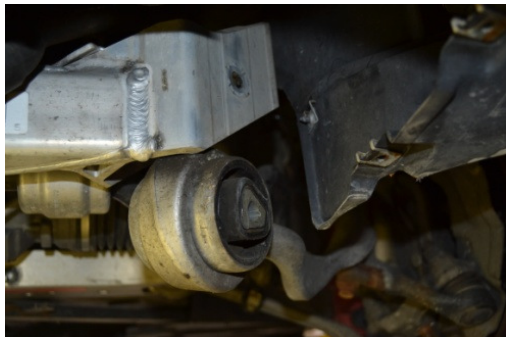
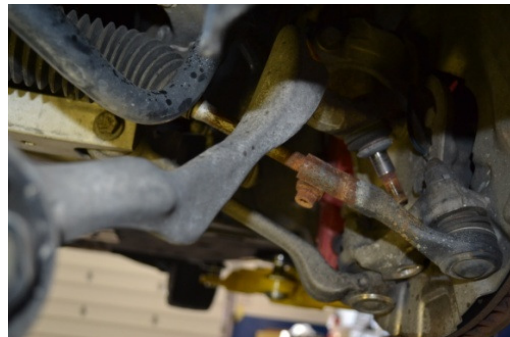
- 7) Remove inner control arm bolt
 - a) Un-fasten bolt for upper control arm with 18mm hex socket
 - b) The nut is captive on the back-side and does not require a wrench
 - c) Remove bushing bolt
 - d) pull bushing-end of the control arm out of the subframe
 - e) lift ball joint up and out of spindle to remove the control arm

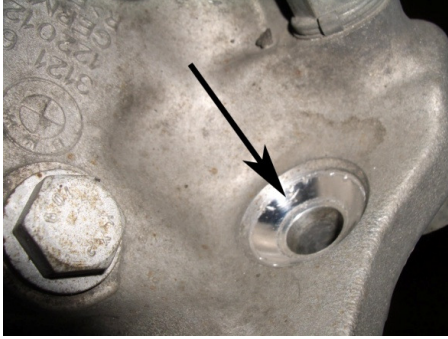
a) Clean/wipe out ball joint cup (in spindle)

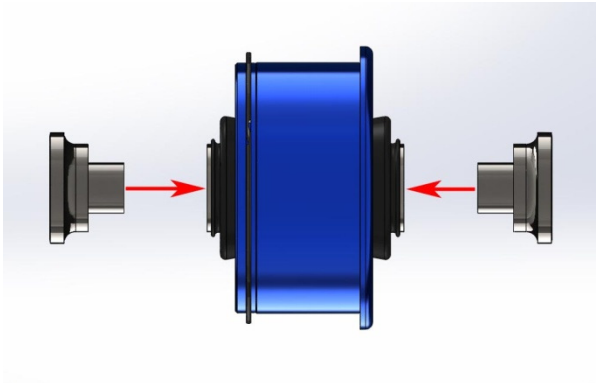
c) Insert stainless steel sleeves into each side of bushing prior to placing bushing end into subframe
